<b>Report No. CF-16</b> : Loss of a Pier Well Foundation for a HL Bridge over a Major River.....	<b>02</b>
<b>Report No. CF-17</b> : Steel Truss Bridge Failure During Launching.....	<b>07</b>
<b>Report No. CF-18</b> : Tilting of Hammer-head Pier of a Metro Viaduct During Service - A Case of Foundation Failure.....	<b>11</b>
<b>About CROSFALL Newsletter</b> .....	<b>16</b>

REPORT No. CF-16

Loss of a Pier Well Foundation for a HL Bridge over a Major River

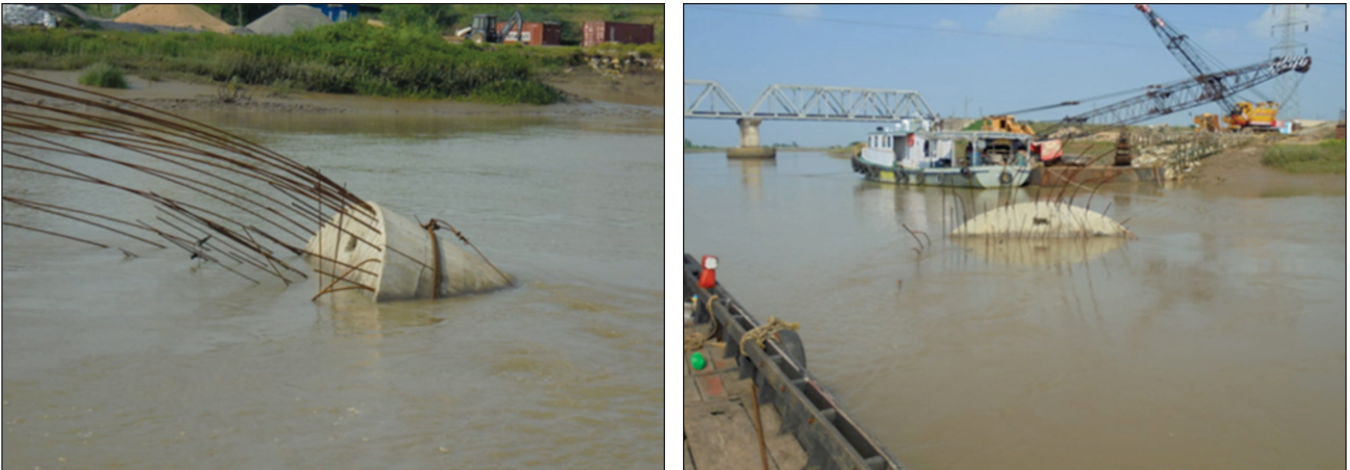
The stream has tidal variations. During the sinking process, at some stage, due to variation in tidal level from High Tide level to Low Tide level, the well got tilted excessively, became unstable, lost control and fell into river due to insufficient grip into the river bed. All efforts were made to bring it to original position but in vain. The well was tightened by wire ropes using three winch machines, but all efforts for improving the well position was unsuccessful. Photographs in Fig.3 & Fig.4 show tilted and fully submerged well.

**Fig. 3 : Excessive Well Tilting**

The loss / damage to the well has been caused due to sudden tidal current and tidal variation in the river. It has not been caused by design deficiency and/or defective material and/or bad workmanship.

When all efforts to set the well right were unsuccessful, it was decided to abandon the tilted well and go for alternative solution. While looking for alternative solution clients requirement also changed in terms of its navigability. In the revised span arrangement, the FRL was raised by nearly 3m to increase the vertical clearance between HFL and soffit of deck so that the central span gets the desired navigational clearance of 30m(H) × 6m(V). Bridge length extended by about 20m on either side by providing RCC box sections

resting on earth. New foundation was installed in place of original P1, which was shifted towards Abutment, thereby increasing the span from 37.33m to 49.15m and reducing the end span from 37.33m to 24.65m. The span between P2 to P3 was provided with steel truss having length of about 50m. Fig. 6 shows the position of well foundation, including the tilted well position.

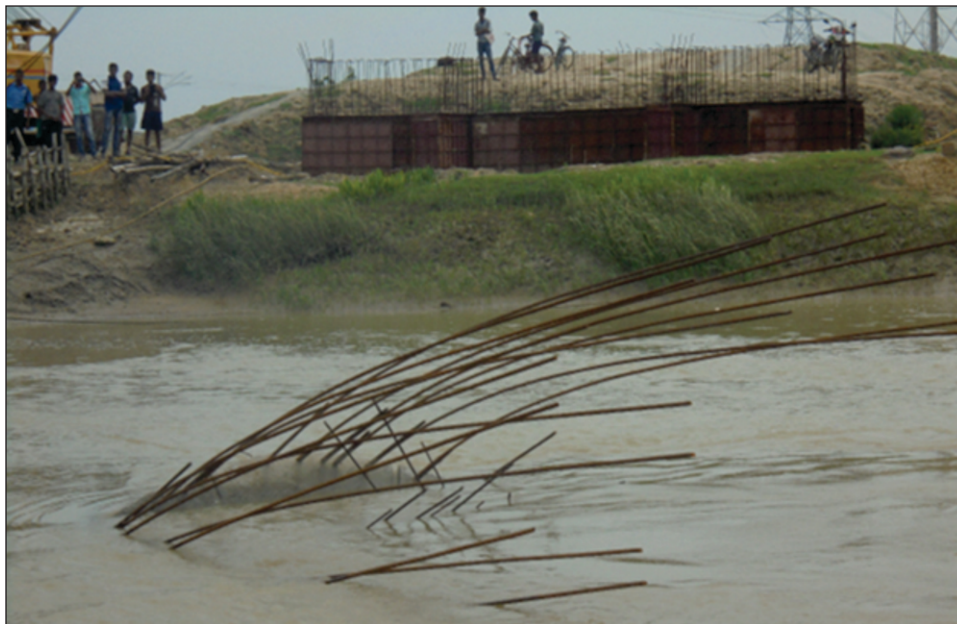
**Fig. 4 : Well - Fully Submerged**

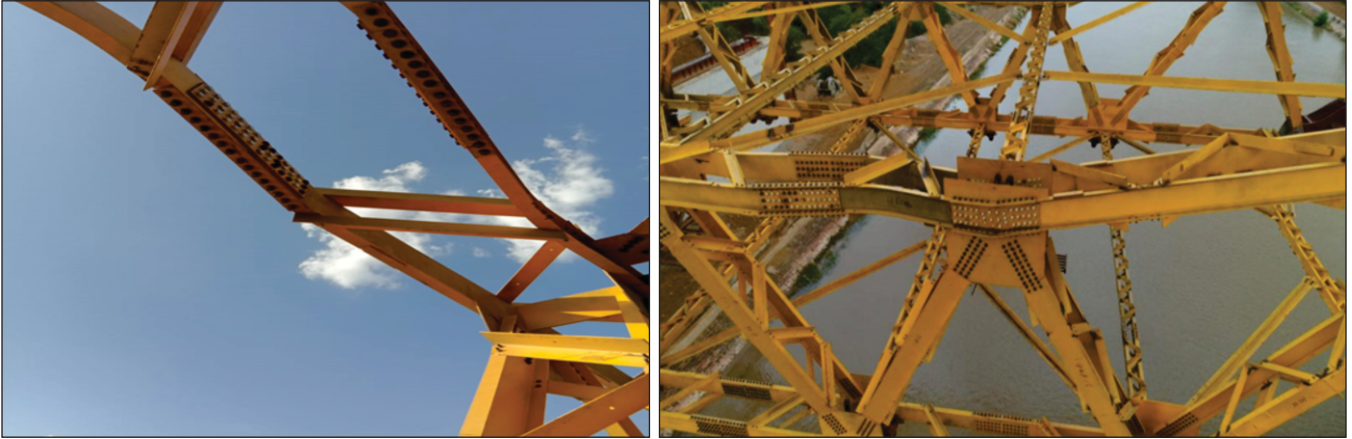
1. The first failure occurred when the first TWO wheels under the "Nose" was supported on the other side abutment. Around 40 m length of main truss had crossed from abutment towards spanning side. In this situation some top members of "Nose" got buckled, creating an alarming situation at site. Fig.3 shows the buckled top chord of the nose.

Fig. 3 : Photograph Showing Buckled Top Chord of Nose

The first failure occurred due to the non-compliance of design drawings for the top chord of the Nose. During cantilevering the Nose top chord is under tension, until it touches down on the support on the far side, when it comes under compression. The spacing between the triangular shaped bracings connected to the top chord, was more than the designed value. Therefore, under compression the top chord buckled due to excessive length of the unsupported member. Generally it is assumed that the weight of the "Nose" is getting distributed equally between the two sides of the truss in an idealized condition. This is theoretically perfect, but in practice it may not be the case. Due to some mismatch or level differences between two sides (which may practically occur at site); one side of truss is more loaded than the other side during launching. It is suggested to consider some additional impact factor over the design load during launching condition.

2. Launching was halted for a few days for rectification of distressed members, and strengthening of some critical "Nose" members for further launching. After rectification, the launching was started again. It was reported when main truss front portion, which was connected with Nose, was about to touch the support, suddenly the connection between the truss & Nose got teared off, with the result, the end of main truss fell down. Fig.4 & Fig.5 shows the photograph of collapse.

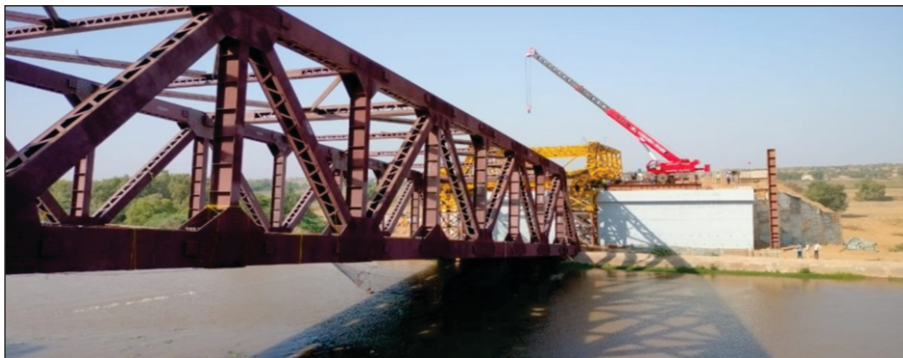
Fig. 4 : Photograph Showing Collapse of Main Truss Launching End

Second failure was almost a disaster, and could have triggered a catastrophic situation at site. Just before collapse of the main truss, the whole system was supported on the last pair of wheels of Nose on the launching side. Almost the total length of truss was spanning supported on Nose wheels, exerting the maximum reaction under this condition on the running beams through the wheels. It was reported that just before collapse of the running beam (below rail) under "Nose" wheel started buckling, initiating the failure of the connection between main truss and Nose truss. It seems the running beam was not having sufficient strength to take the reaction which it was bearing. Trestle/crib supports which were proposed underneath the running beam were missing. This Trestle/crib supports would have provided sufficient support to running beams, and the collapse could have been avoided.

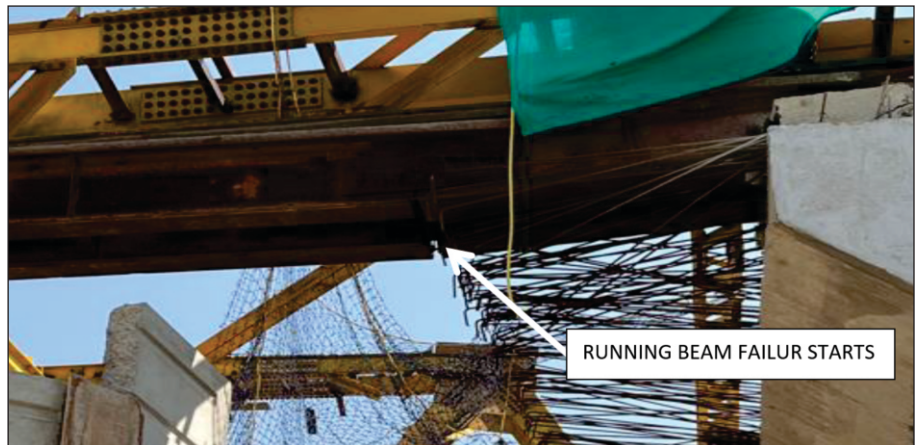
Fig. 5 : Photograph of Running Beam at Failure Side

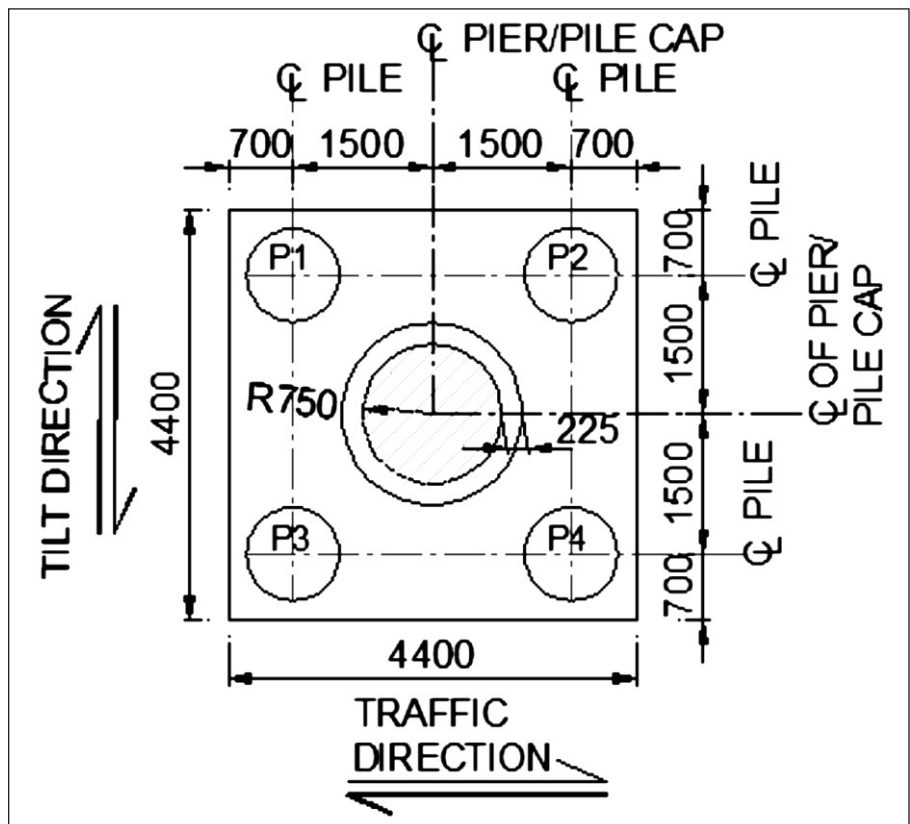
Fig. 1 : Plan of Foundation

From the above findings, it is extremely evident that no socket length had been provided for Pile number P-3 and P-4 when they were constructed. This absence of socket in these two piles would have resulted into the settlement of the piles P-3 and P-4, thereby creating a rotation of the substructure in the transverse direction (normal to the direction of traffic), which had been ultimately observed as tilt on a broader scale above the ground.
