# Collapse of Precast Arch during construction

## Submergence of High-level Bridge Due to Unprecedented Floods Leading to Unique Rehabilitation Scheme

# Structural Collapse of a Canopy of Platform (COP) during Construction

**Stealing of Fencing wires, Solar Panels, Batteries, Metallic Crash Barriers and parts of Electric Poles from Highways and Expressways – A growing menace**

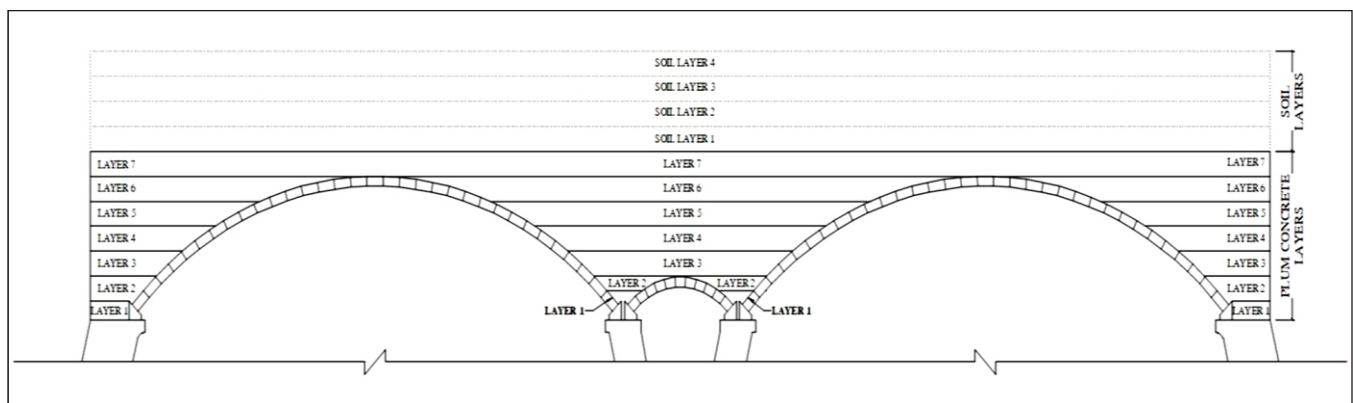
Fig. 3 : Construction Sequence of Arch Deck - Indicating Plum Concrete Backfilling in Layers.

- a. The filling above the arches was proposed in layers of plum concrete of 1m height simultaneously to be carried out on both end of the arches and in between. Fig 3 shows the schematic arrangement of proposed layers of plum concrete.
- b. The philosophy behind the filling was to fill the plum concrete without causing any uneven loading on the arches. Therefore, it was proposed as a standard practice to restrict the difference between any two adjacent layers of plum concrete on both side of the arch to 1m.

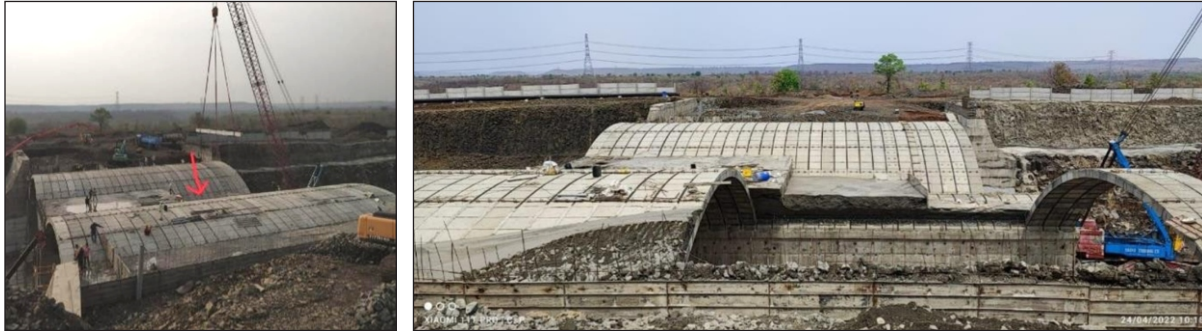
A part of the bridge collapsed while the backfilling over the arch was in progress at the site. At the time of the collapse, the bridge was in an advanced stage of construction. Erection of 101 out of 105 arch strips were completed. The erection of balance 4 Major Arch Strips was scheduled to be started in the morning of the next day and to be completed by day end. The principal reason for the collapse is the unequal and unbalanced filling of plum concrete over the arch, causing uneven loading, which should have been avoided. Filling above the arches should have been carried out simultaneously at both ends of the arch. Post collapse data collected by the reporter revealed that the level difference between fillings on either side

of the arch, in collapsed arches (15 out of 35 arches) was over 4m. This is expected to have created unequal loading above the arch strips, leading to failure.

Opening of the project was preponed by a months' time resulting in continuous concrete schedule. On the night the failure occurred, there was no expert supervisor present at the time of concreting at the site. The concrete boom placer was placed on the wrong side due to lack of information to the operator in the absence of the engineer. Failure took place at 02:30 AM. Fig. 4 shows the photograph before and after collapse, clearly indicating the difference in fill height.

Fig. 4 : Photo just before and after collapse

- a. Every single activity on the site must be carried out after thorough understanding of the drawings issued and as per duly prepared and approved method statements.
- b. Until the end of the project, communication channel must be kept open between designer, consultant, and execution site team.
- c. Expert supervision is very important in the construction of specialized structures.
- d. Minimum time required for the construction of the structure shall be given to the contractor without squeezing the timeline. Hectic working hours on construction site shall be avoided as far as possible, lengthy working hours increase the risk of making mistakes by engineers, supervisors and workers.
- e. Construction procedure and sequence given in the drawing must be followed on site.

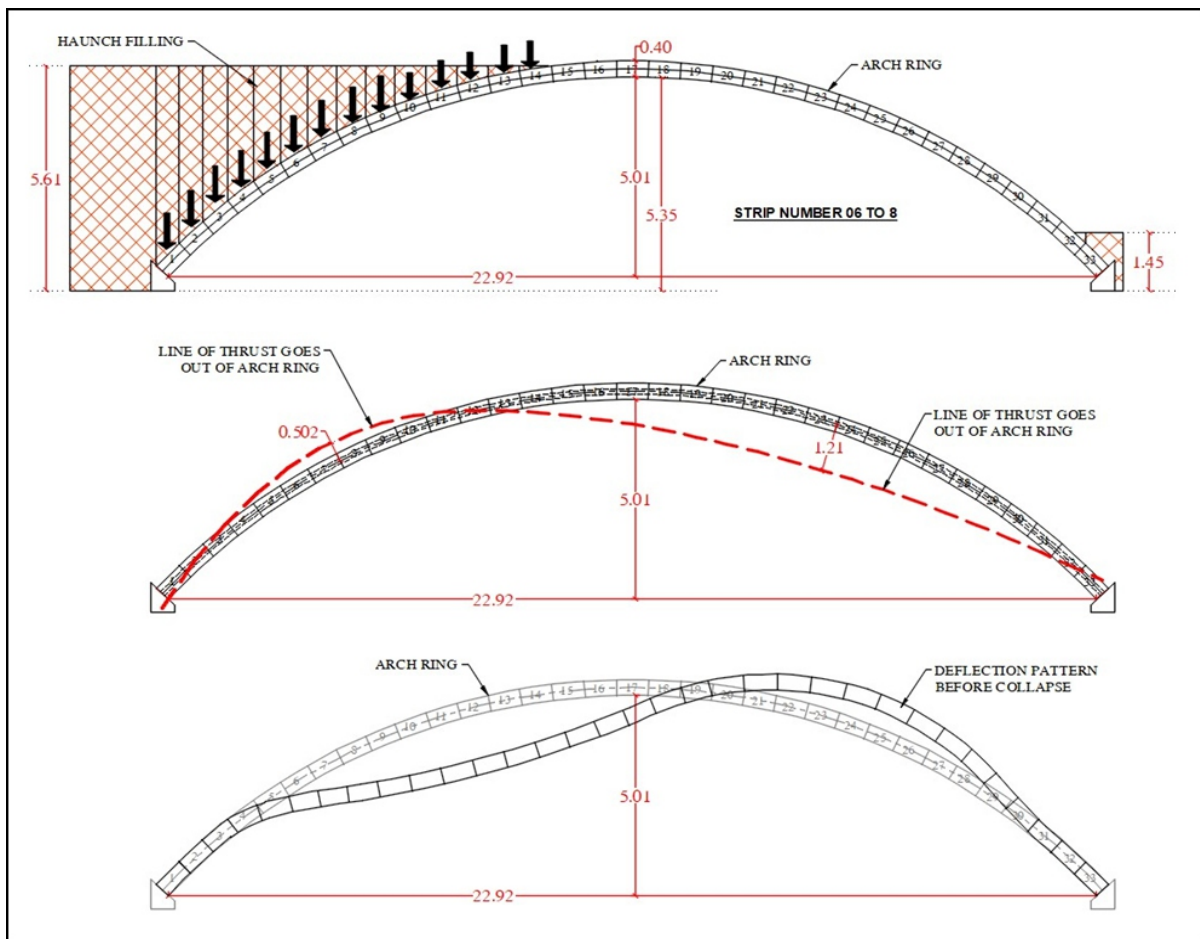
Fig. 5 : Graphical analysis showing line of thrust and deflection of unstable arch just before collapse due to uneven loading of plum concrete on both ends of the arch ring.

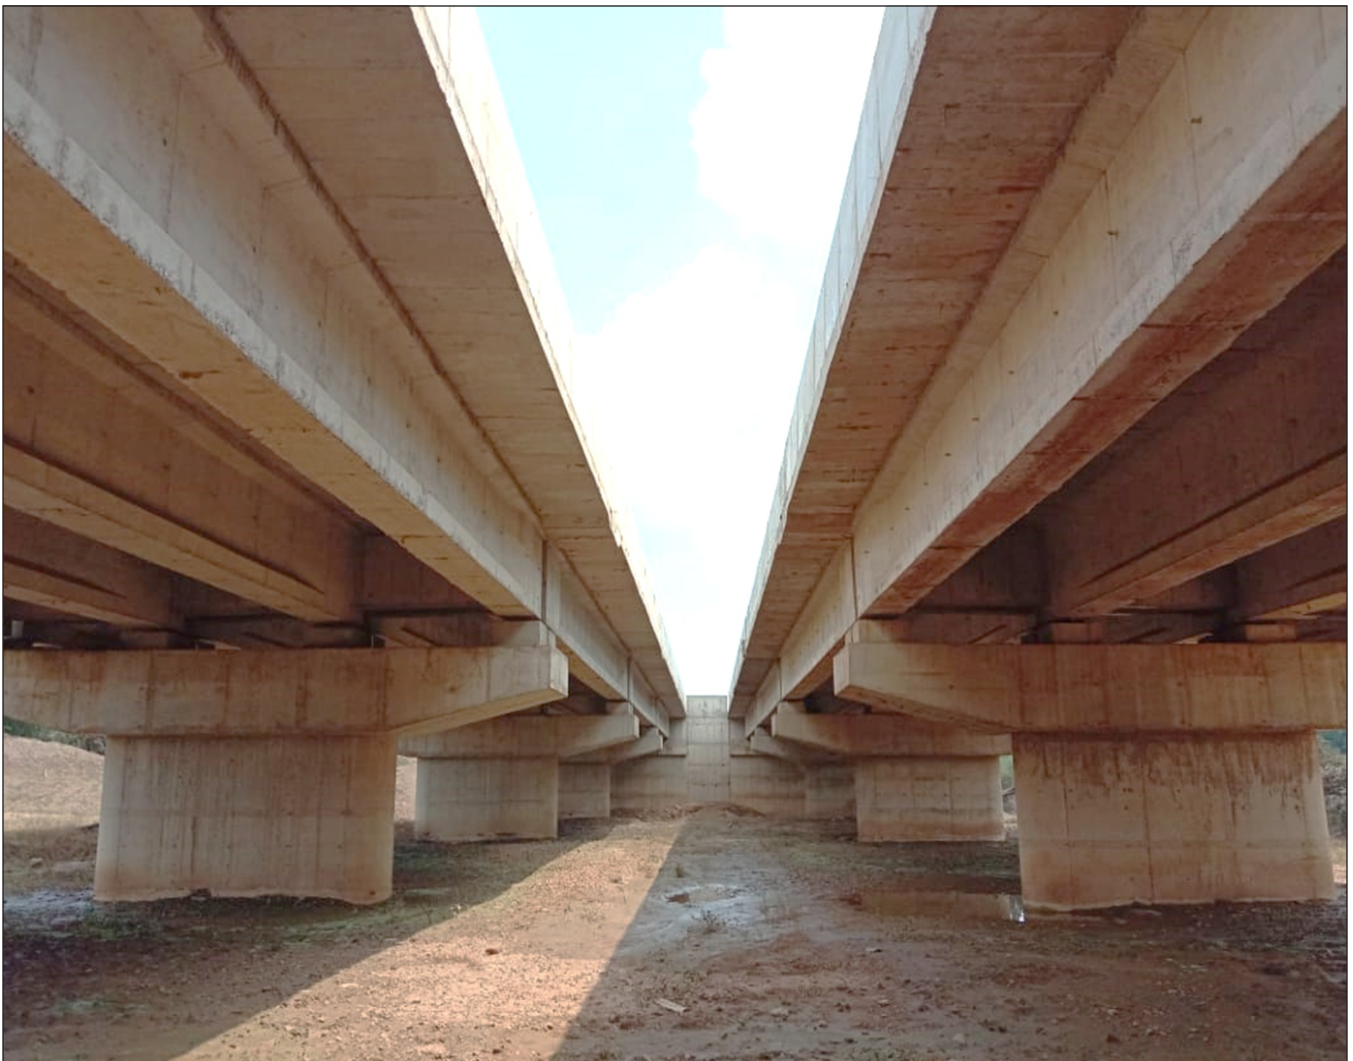
Fig. 1 : Major Bridge on NH passing through rural central India

Major bridge was opened to traffic and as mentioned above, it was performing well on all parameters. However, in the year 2019, unprecedented rainfall was witnessed in this area. This rainfall intensity of 100-year return period rainfall intensity which is generally considered in the hydrology calculations was breached. Rise in Highest Flood Level (HFL) was so huge that it crossed Finished Road Level (FRL) and this high-level major bridge went underwater. The submergence of this crucial connecting link caused havoc, especially during the flood. Many villages and towns were immediately disconnected from the rest of the highway. Huge traffic congestion of trucks, buses, ambulances and all other vehicles were noticed on either side of this submerged bridge waiting for the flood water to recede.

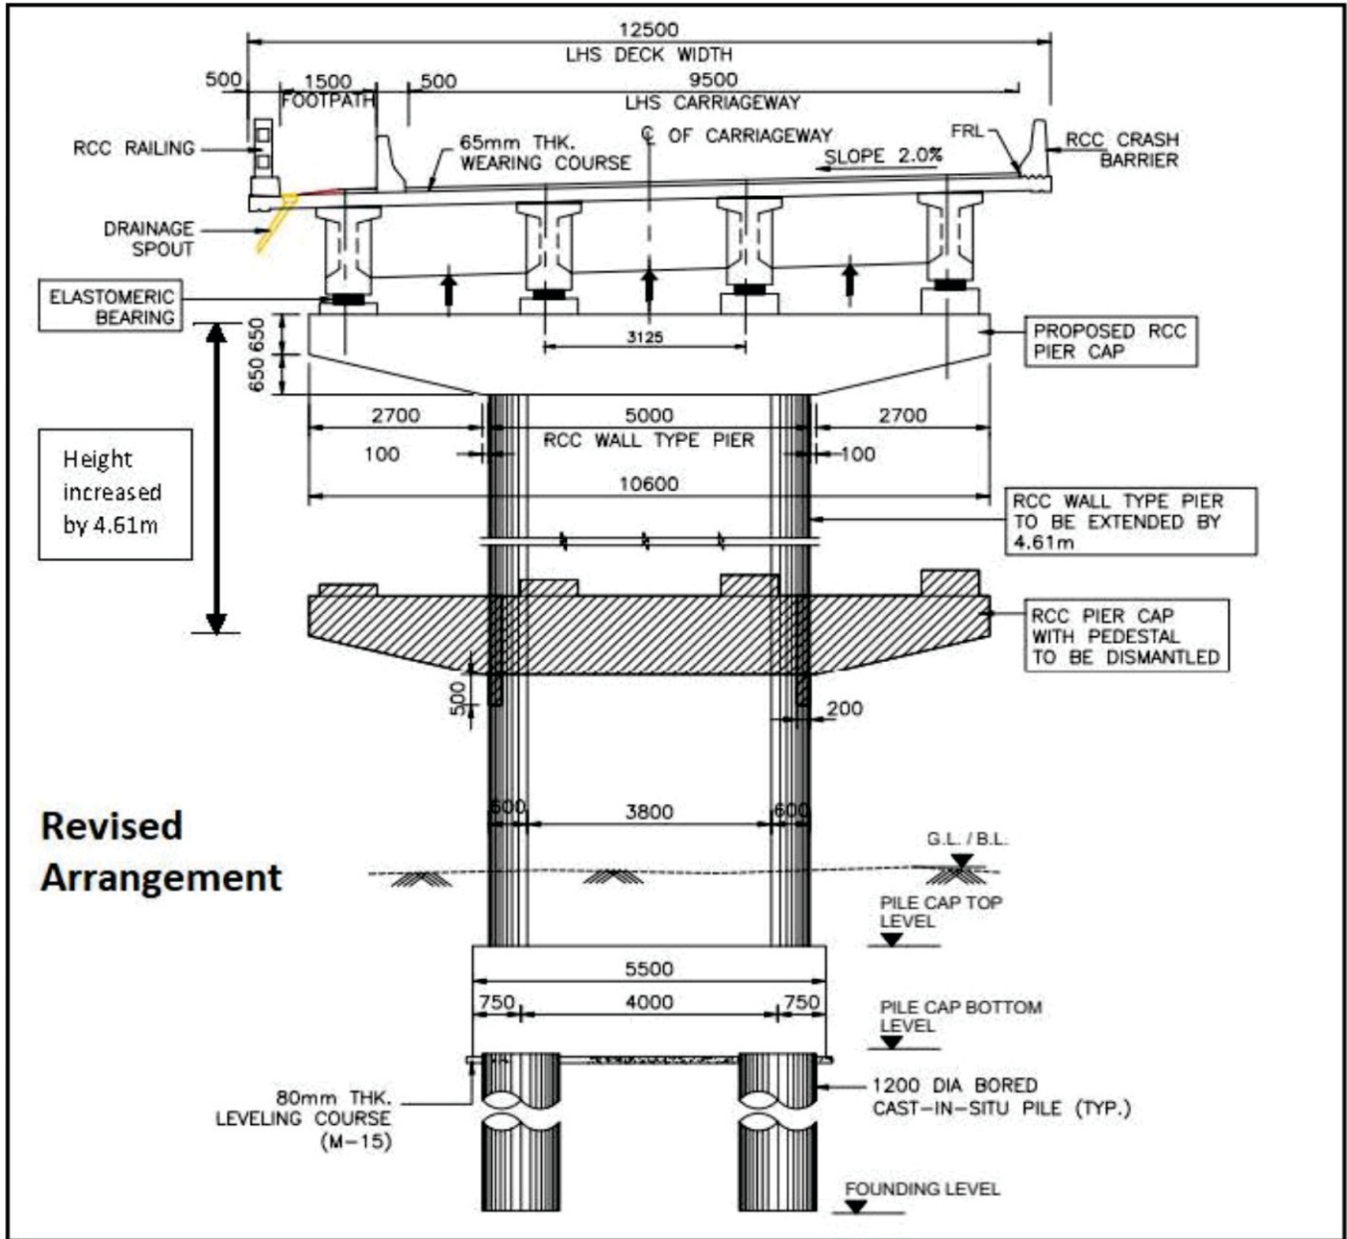
Fig. 3 : Revised Arrangement after rehabilitation

Structurally, all spans are simply supported. Superstructure type is pre-cast RCC girder supporting cast-in-situ deck slab and resting on POT-PTFE bearings. Detailed study of all design documents and drawings were done to understand loads and governing combination of design. As the FRL of this bridge is to be increased, same superstructure with existing reinforcement need to be used. But additional load due to rise in height of pier and due to greater earth pressure behind abutment have been checked against existing pile foundation and substructure bottom.

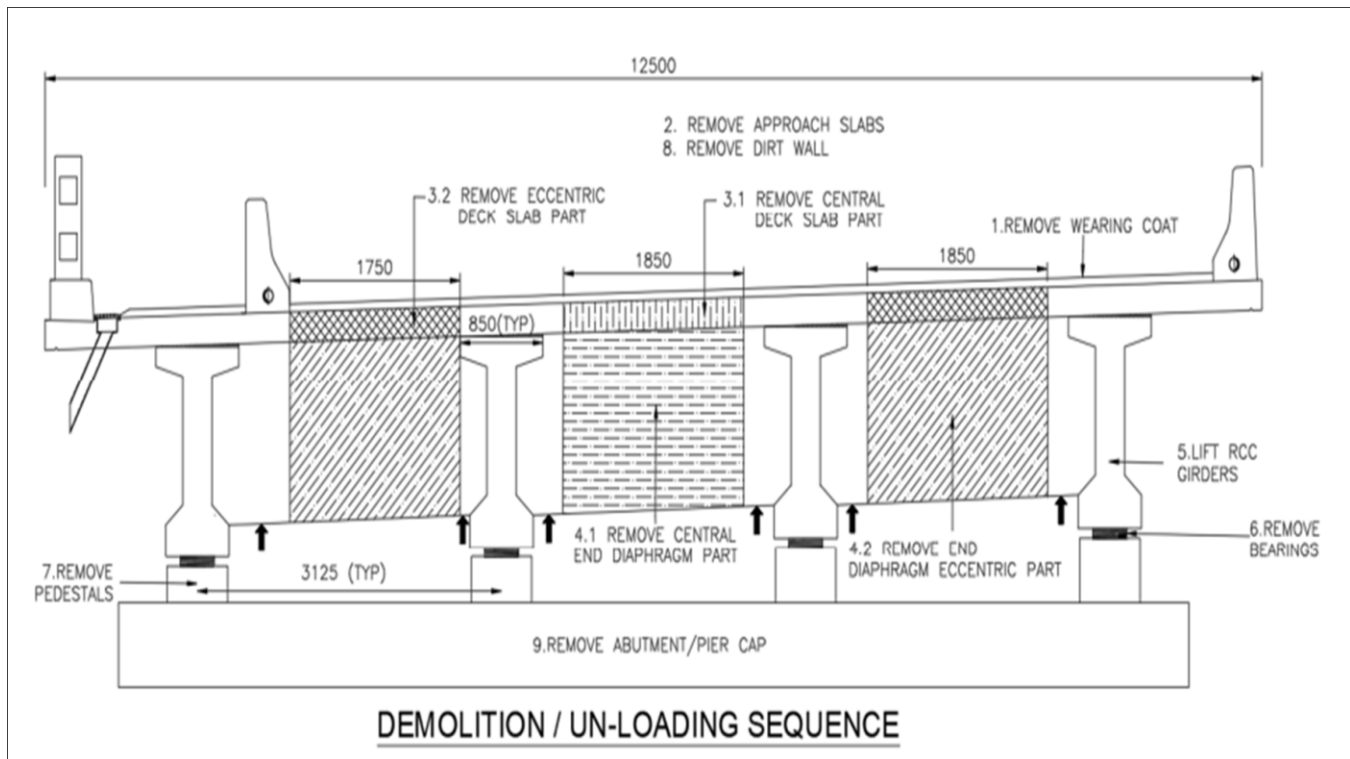
Fig. 4 : Demolition sequence of Superstructure

1. Superstructure was dismantled as shown with sequence. (Refer figure 4)

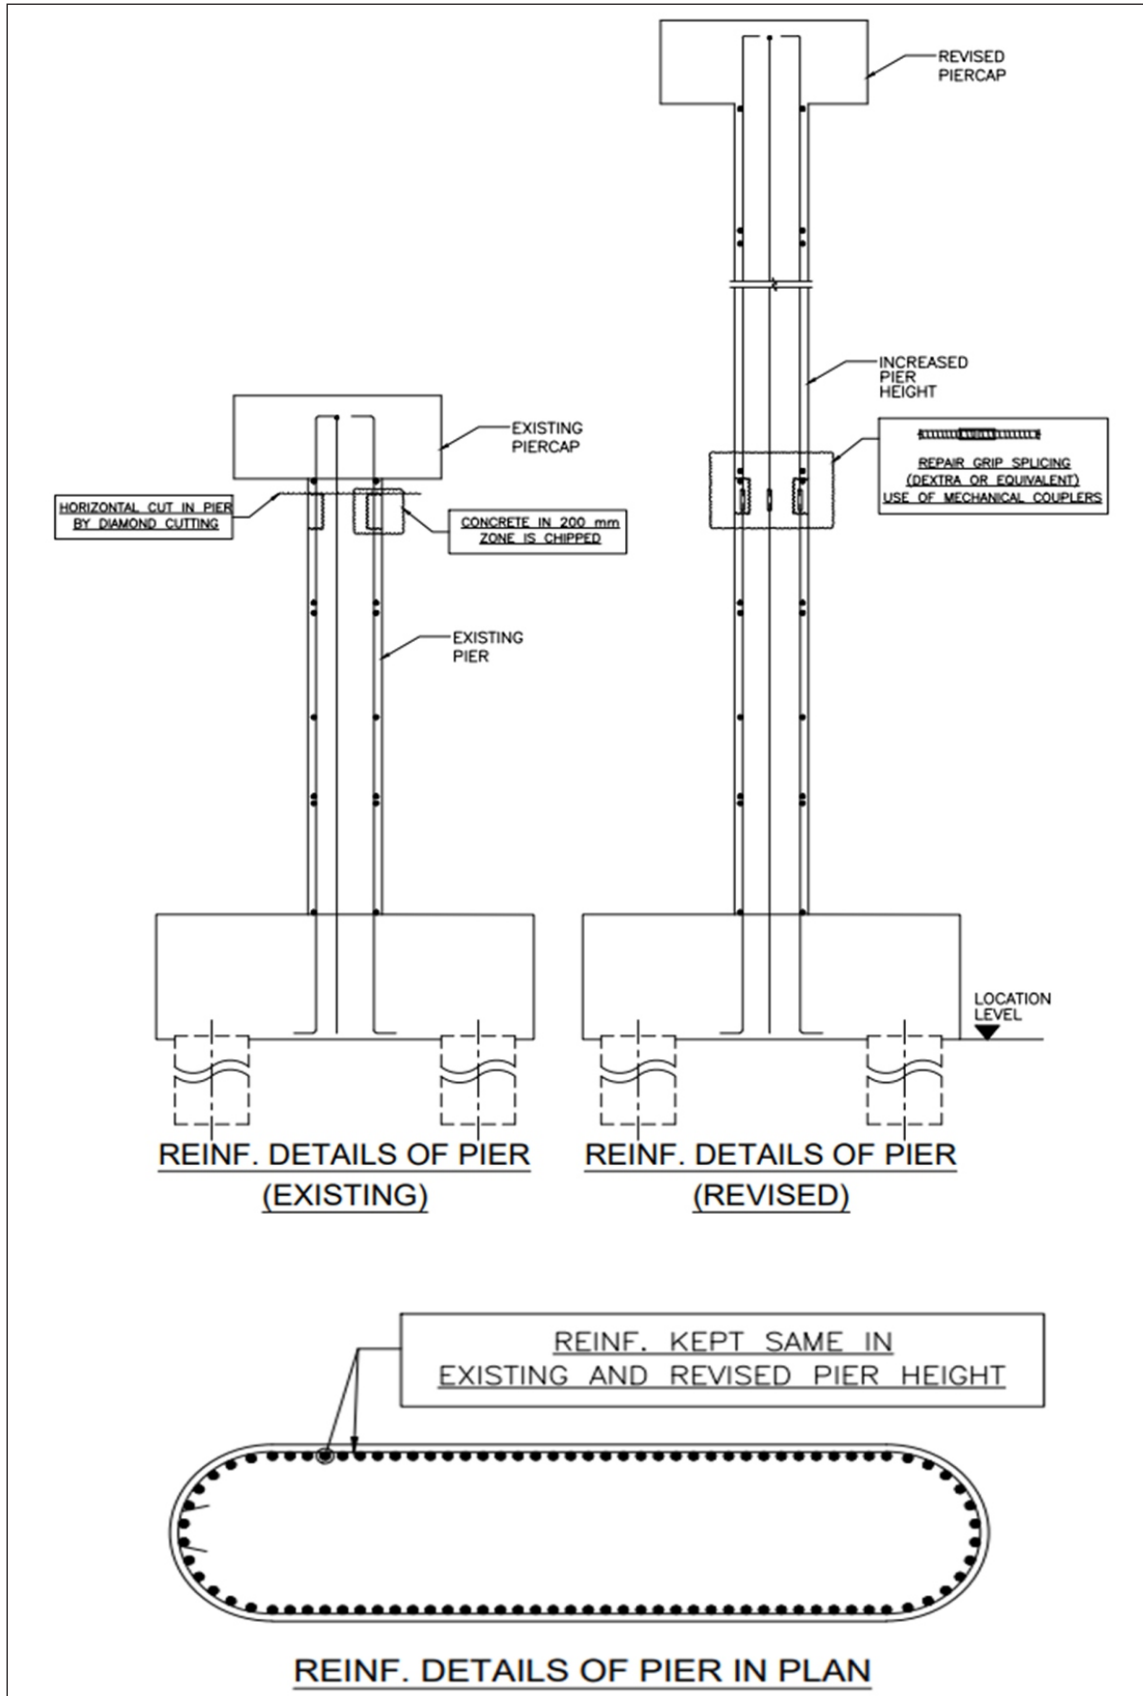
Fig. 5 : Schematic diagram for Revised reinforcement in Pier

2. A horizontal cut in the pier was made and new vertical reinforcement was lapped with existing reinforcement to ensure structural connectivity. After the horizontal cut in the pier is done using mechanical cutting machine, old vertical bars are then connected to new reinforcement using repair grip couplers. (Refer figure 5 & 6)

With respect to lapping of new bars with existing bars of pier and abutment, mechanical couplers as recommended by IRC 112 clause 15.2 were used. These couplers from approved vendors ensured that required lap length between new and existing reinforcement is ensured. Also, a detailed demolition methodology of deck slab and diaphragm mentioning systematic step wise process along with their re-casting was prepared. It was ensured that under no construction stage, any unforeseen load path gets generated hampering sound working of the structure.

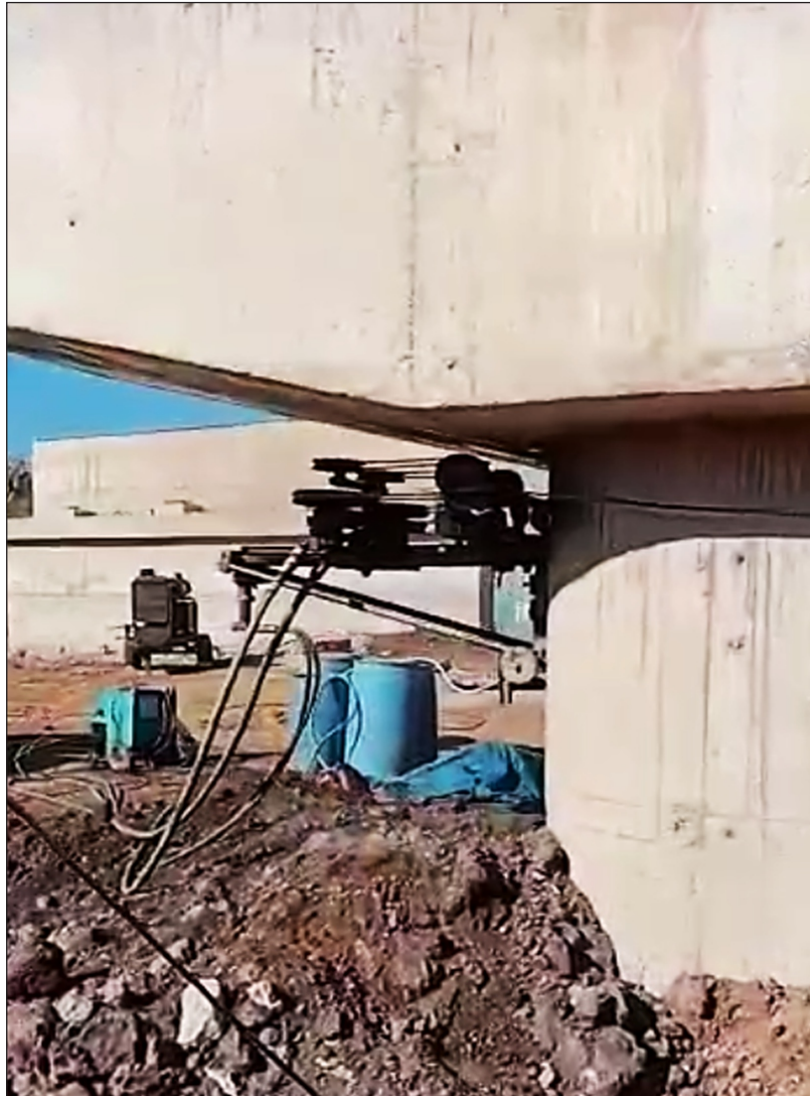
Fig. 6 : Image showing pier being horizontally cut by diamond cutting.

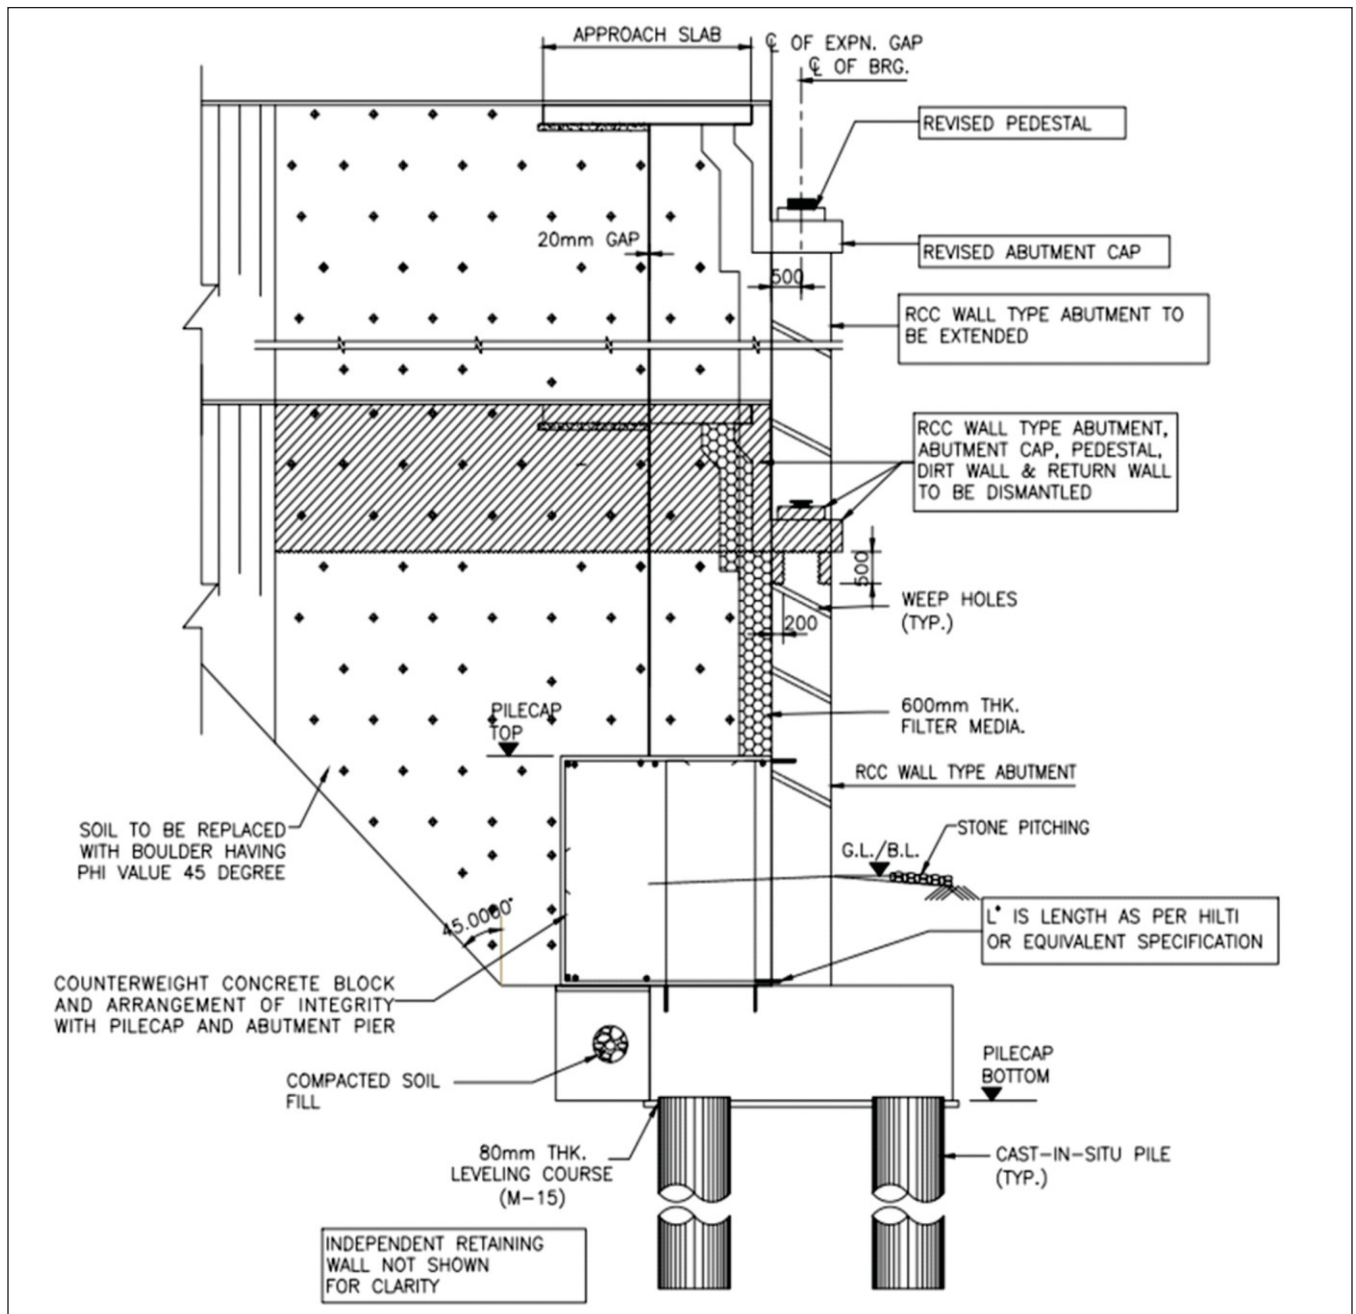
However, additional load due to increased height of earth pressure behind the abutment was exceeding vertical load carrying capacity in piles. Fortunately, horizontal load carrying capacity of the pile was not exceeded even for increased height. To counter additional longitudinal moment due to active earth pressure, a counter-weight concrete block of size 3.6m x 3.55m x 12.5m was integrated with earthen side of the abutment. This counter-weight block replaced soil (with unit weight 2 ton/m<sup>3</sup>) with concrete (with unit weight 2.5 ton/m<sup>3</sup>). Back fill of both abutments was completely changed from cohesionless soil having  $\phi = 30^\circ$  as per appendix VI of IRC 78:2014 to selected boulders with  $\phi = 45^\circ$ . Both these structural changes reduced earth pressure on the abutment and provided reinforcement in pile foundation and abutment bottom was found safe.

Fig. 7 : Structural changes behind abutment

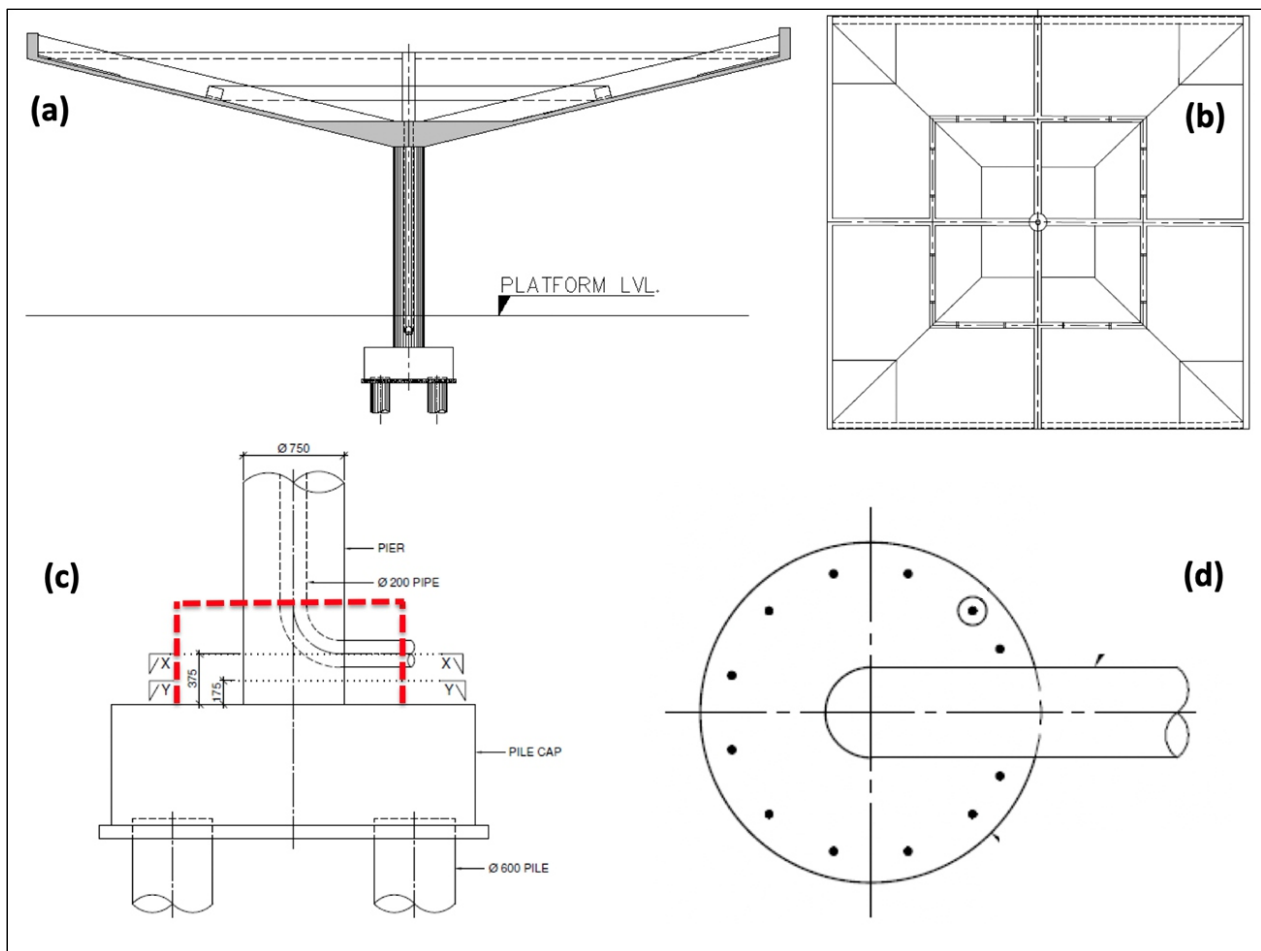
Fig.1 : (a) Elevation of RCC canopy of platform (b) Plan of the roof (c) Elevation at the bent drainage pipe (d) Effective cross section area at bent drainage pipe

- The inverted pyramid of size (18m x 18m) is concentric about the CG and is supported by a small 750 mm dia. column. Any error in maintaining the verticality of the column and to construct the roof concentrically may create huge imbalanced eccentric moments in the column.
- For any reason, if the drainage pipe is choked, the inverted pyramid may get filled up with water, the eccentricity because of the casting imperfections in roof clubbed with additional accumulated water load may magnify the moment effect in the column.
- Where the drainage pipe is bent at the top of the pile cap, the effective cross section area is reduced to a large extent. The line of fall is in proximity of around 18.5° in the direction of the bent pipe.

- c) The drain pipe is bent at the top of pile cap, making the section weaker at that location. To compensate for the same, the area of concrete at that location may be increased by provision of pedestal as shown in the Fig.1(c) red dotted lines.

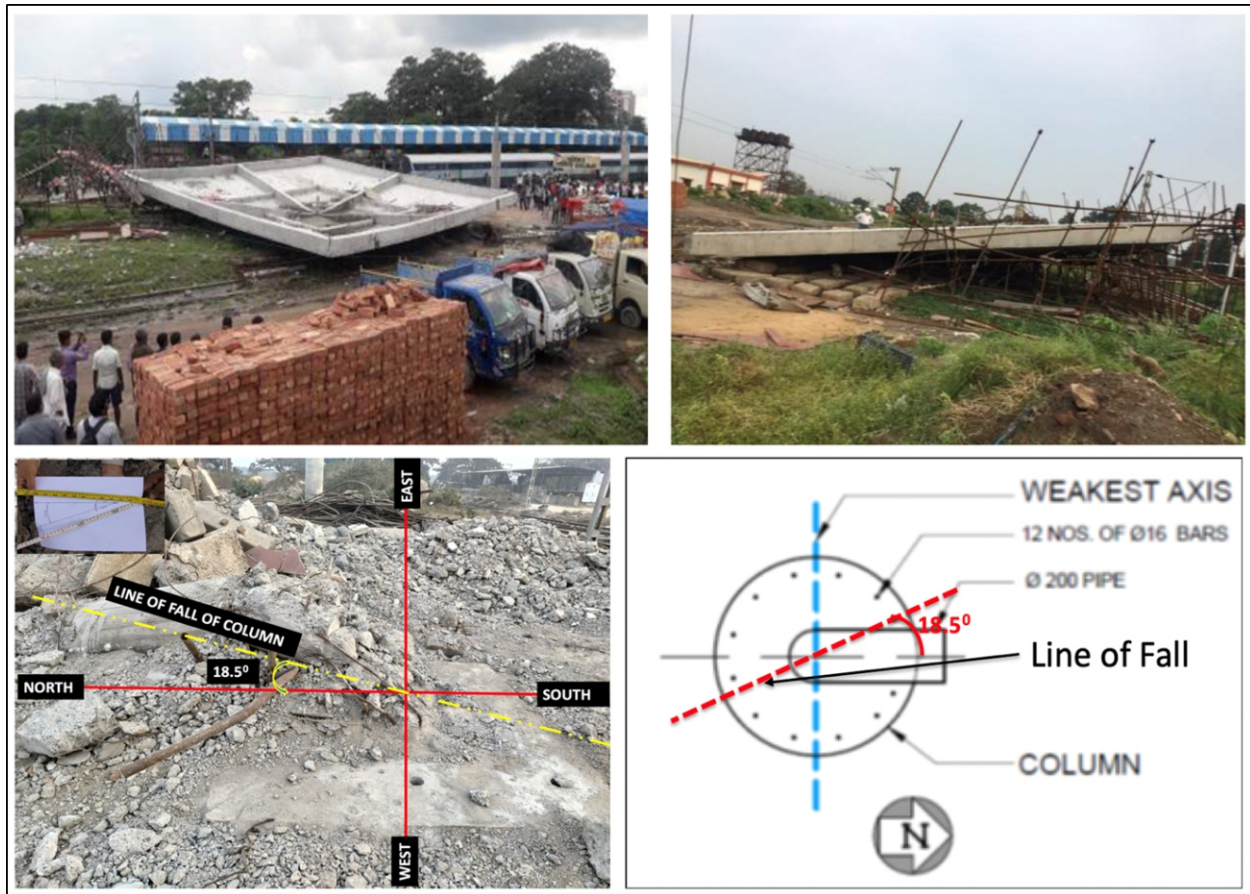
The RCC platform roof structure under construction collapsed suddenly nearly after 5 months of casting of the roof slab and standing unsupported for three weeks after the removal of shuttering/formwork. The mapping of the debris after the collapse revealed that there was no failure of the slab and the same came down as a single body (Fig.2). The minor distresses that were visible in roof elements were due to the impact of the collapse and the roof frame remained intact. The roof was supported on a single column. It was obvious that the roof came down because of the collapse of the column. The column had fallen down at around 18.5° away from the bent drainage pipe (Fig.2). The column had broken at two locations, i.e. at around 175mm which is just below the bent drainage pipe and 900mm from the top of the pile cap.

Fig.2 : Collapsed COP showing roof, column and Line of Fall

The first crack seemed to have occurred at 175mm above pile cap which is just below the bent drainage pipe. The concrete quality underneath the pipe may not be good. The casted roof was supported on shuttering for nearly 5 months. The collapse took place after 3 weeks of decentering. If the decentering is not done in a prescribed sequence, there is a possibility of excessive moments due to eccentricities created during decentering causing distress in the column. If already distressed column is subjected to any trigger like the wind load, the collapse can take place.

- a) The success of this kind of single support column, depends on proper design and detailing taking all load combinations especially the wind load due to its large cantilevered roof area and the quality of the workmanship including maintaining verticality of the column and casting large roof without imperfections causing eccentricities.

- b) For the drainage of water, there is a drain pipe of 200mm centrally placed in the column. For any reasons, during or after the construction if the drain hole is closed, the water may get collected in the roof and by virtue of eccentricity of imperfect casting of the roof may give rise to huge moments in addition to self-weight. Therefore the structure should be designed for the condition of canopy fully filled up with the water.

- d) Such structures are sensitive to wind load suction, when the train is passing from one side and sometimes accounting for the same may not be accurate due to the shape of the roof. The overturning moment calculations caused due to suction of the wind has to be done on conservative side.

- e) This type of RCC COP, large roof supported on single column does not have built in redundancy. In addition to strict quality control for precision during construction, structural deterioration due to aging may lead to catastrophic failure during the service. This can happen if the structure is not maintained and its health conditions are not properly monitored. The railway platforms being a public place is always crowded with people, this type of COP should be discontinued.

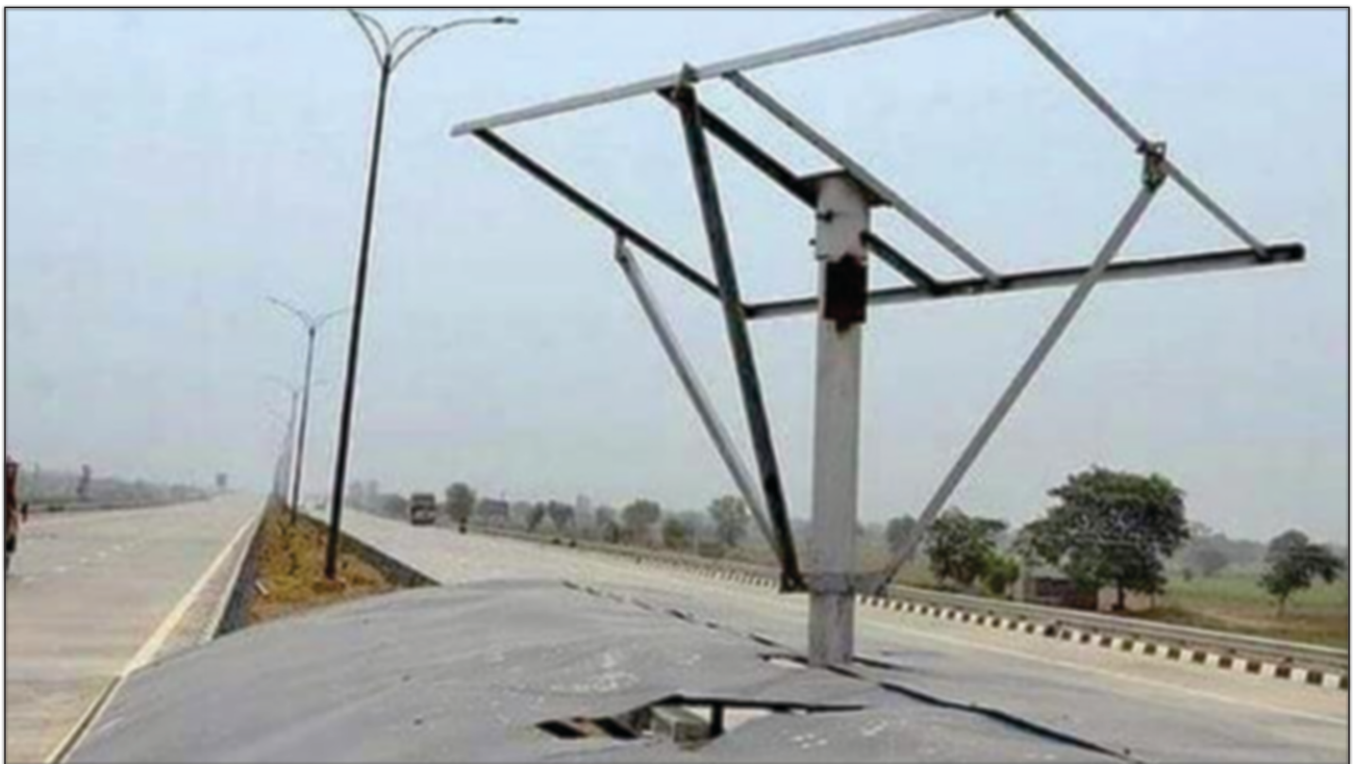
Solar panels, batteries, lights and so many other things have been stolen from the highway soon after the highway was opened to public. Fig. 1 shows a picture of missing solar panel from one of the expressway in northern India. Similar situation exists in other parts of the country as well.

**Fig. 1 :** Missing solar panels along the Expressway (pic via Twitter)

It is recommended that authorities may increase patrolling and surveillance and implement Intelligent Highway Information and Traffic Management System (IHI-TMS) to control accidents and thefts of public assets especially metal parts along highways and expressways and metropolitan roads. Once theft is reported to or noticed by the authorities, it is important to take prompt action to restore the structures so as to avoid any accident due to lack of safety measure.

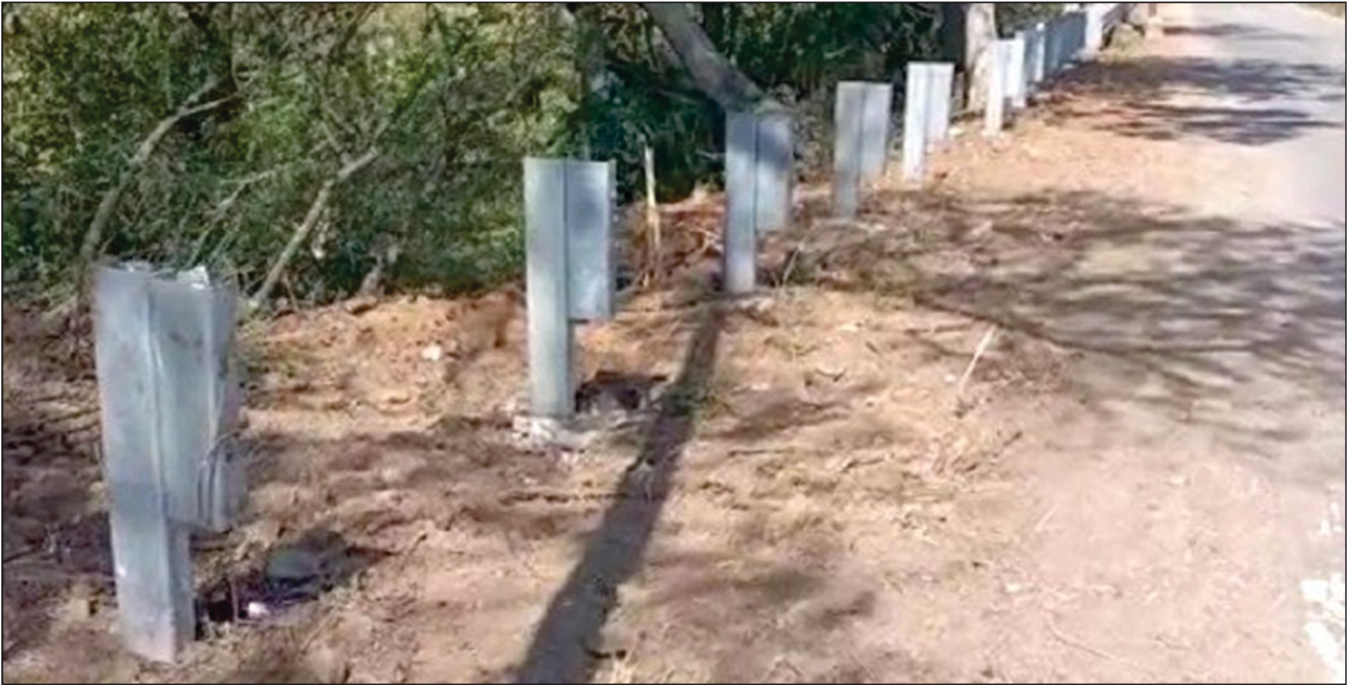
It is reported that the thieves are blatantly cutting off metallic crash barriers to sell them in scrap yards. Fig. 2 shows missing metallic crash barriers along the state highway.

Fig. 2 : Missing metallic crash barriers along a state highway

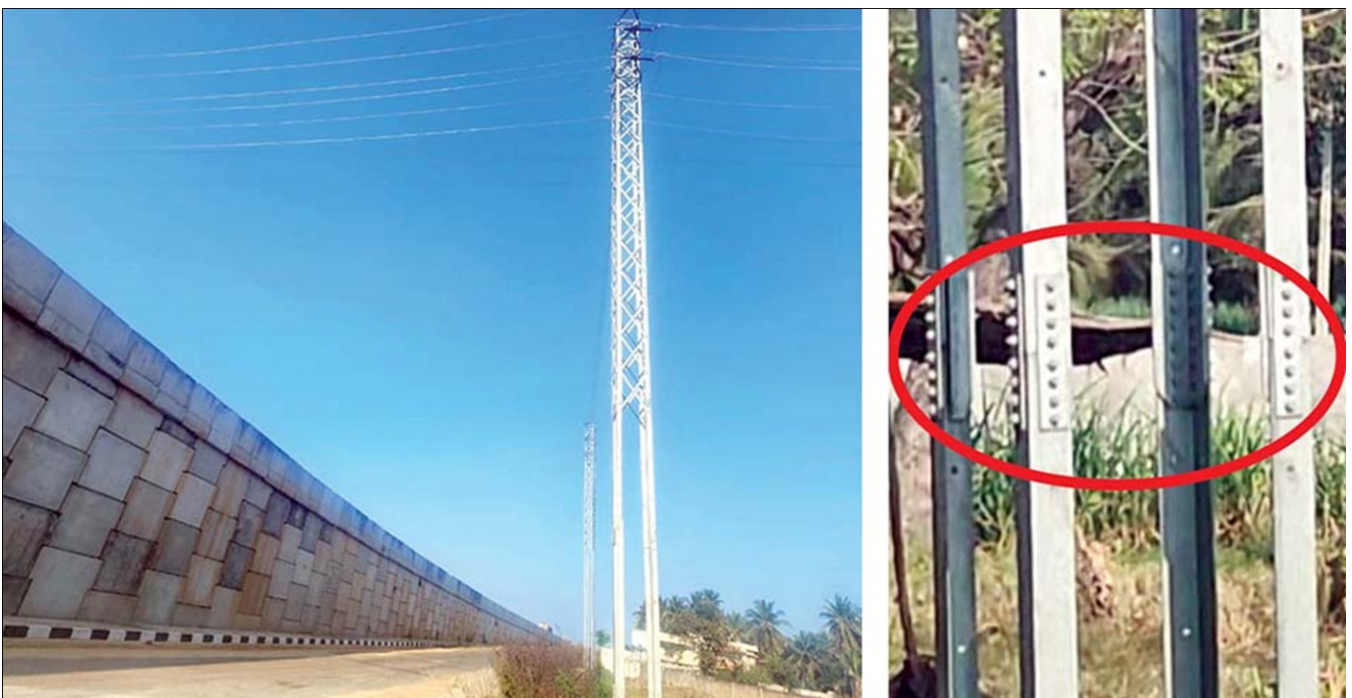
Thieves are also removing the battens and lacings from electric poles, from the bottom accessible part of the pole, without realising the consequences. Fig. 3 shows a typical such pole where the lacing and battens are stolen. As the lacings on the bottom half of the vertical poles have been removed, the poles are becoming structurally vulnerable, unsafe and there is a danger of them crashing down on commuters travelling on the road.

Fig. 3 : Missing lacings and battens in electric poles along the Expressway

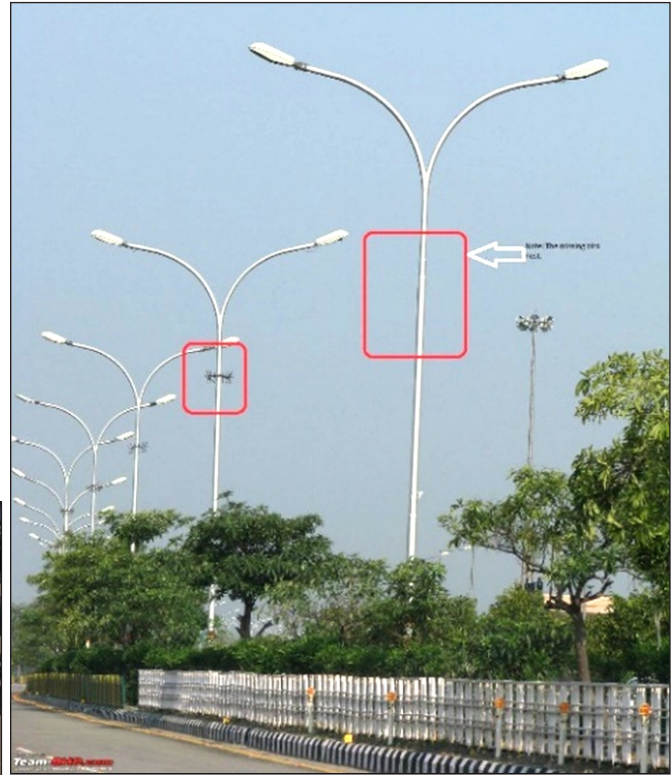
In one case, the bird installed nests from the electric poles were found missing (Fig. 4). In another case, miscreants stole the traffic bollards from the traffic island in a metropolitan city. This happened despite the fact that CCTV surveillance was there near the traffic island (Fig. 5). Theft of government property is so rampant and blatant on the streets that its solution looks to be a challenging task. The reporter comments that it is an unfortunate development. Authorities carry out development works for public benefit and there are some anti-social elements who destroy public property without realising safety is

**Fig. 4 :** Missing Bird's nest in electric pole

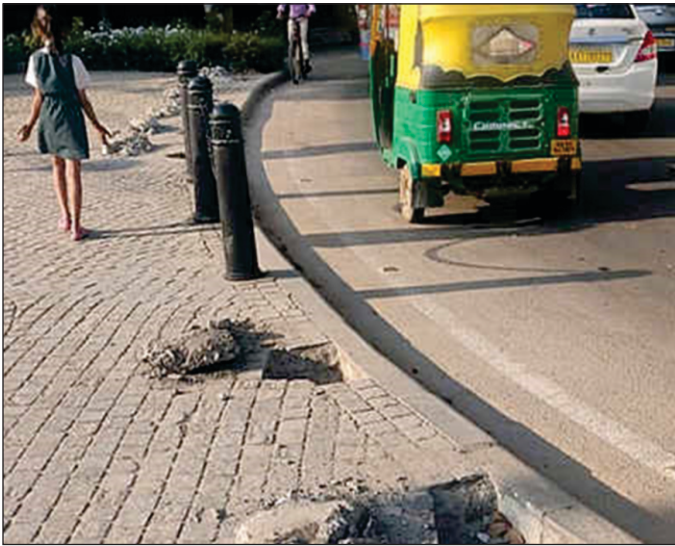
**Fig. 5 :** Bollards stolen despite CCTVs near the traffic island

endangered. The authorities need to beef-up highway patrolling and implement an Intelligent Highway Information and Traffic Management System (IHI-TMS) to control accidents and curb theft of metal barricades, electric poles and other items.
