<b>Report No. CF-16</b> : Loss of a Pier Well Foundation for a HL Bridge over a Major River.....	<b>02</b>
<b>Report No. CF-17</b> : Steel Truss Bridge Failure During Launching.....	<b>07</b>
<b>Report No. CF-18</b> : Tilting of Hammer-head Pier of a Metro Viaduct During Service - A Case of Foundation Failure.....	<b>11</b>
<b>About CROSFALL Newsletter</b> .....	<b>16</b>

REPORT No. CF-16

Loss of a Pier Well Foundation for a HL Bridge over a Major River

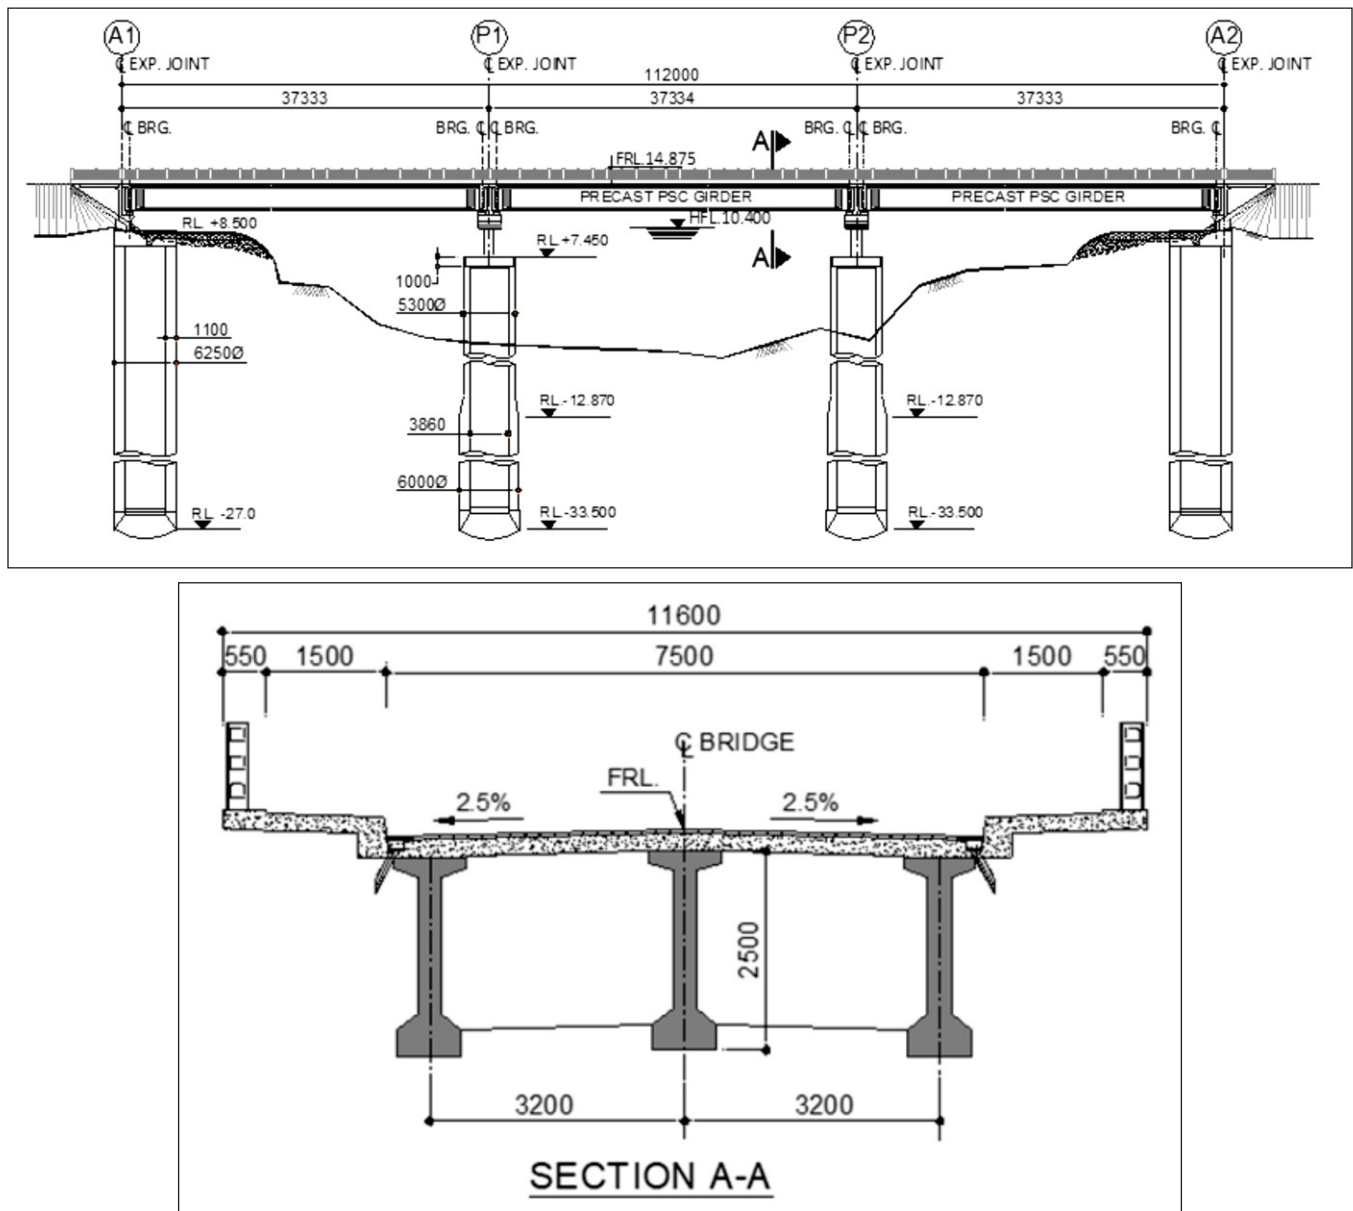
Fig. 1 : Original General Arrangement Drawing

This is the story of a 2-lane bridge across a stream with tidal variation, where one foundation had to be abandoned during the construction stage due to excessive filtering of well foundation. The bridge, as per the original scheme comprised three spans of 37.333 m each with an overall bridge length of 112m between c/c of expansion gap at the abutments. It comprised of two intermediate pier P1 & P2 and two abutment A1 & A2, all resting on well foundations, as shown in Fig. 1.

Pier well P1 (location as per original GAD) got tilted excessively during its sinking operations and had to be abandoned. Span arrangement was modified on account of abandonment of original pier well P-1 by introducing a larger span of 49.15m bridging across the abandoned well as shown in Fig. 5. Steel trussed type of superstructure proposed for longer span, in order to control weight on other well foundation P2, which was originally designed to carry 37.33m PSC span.

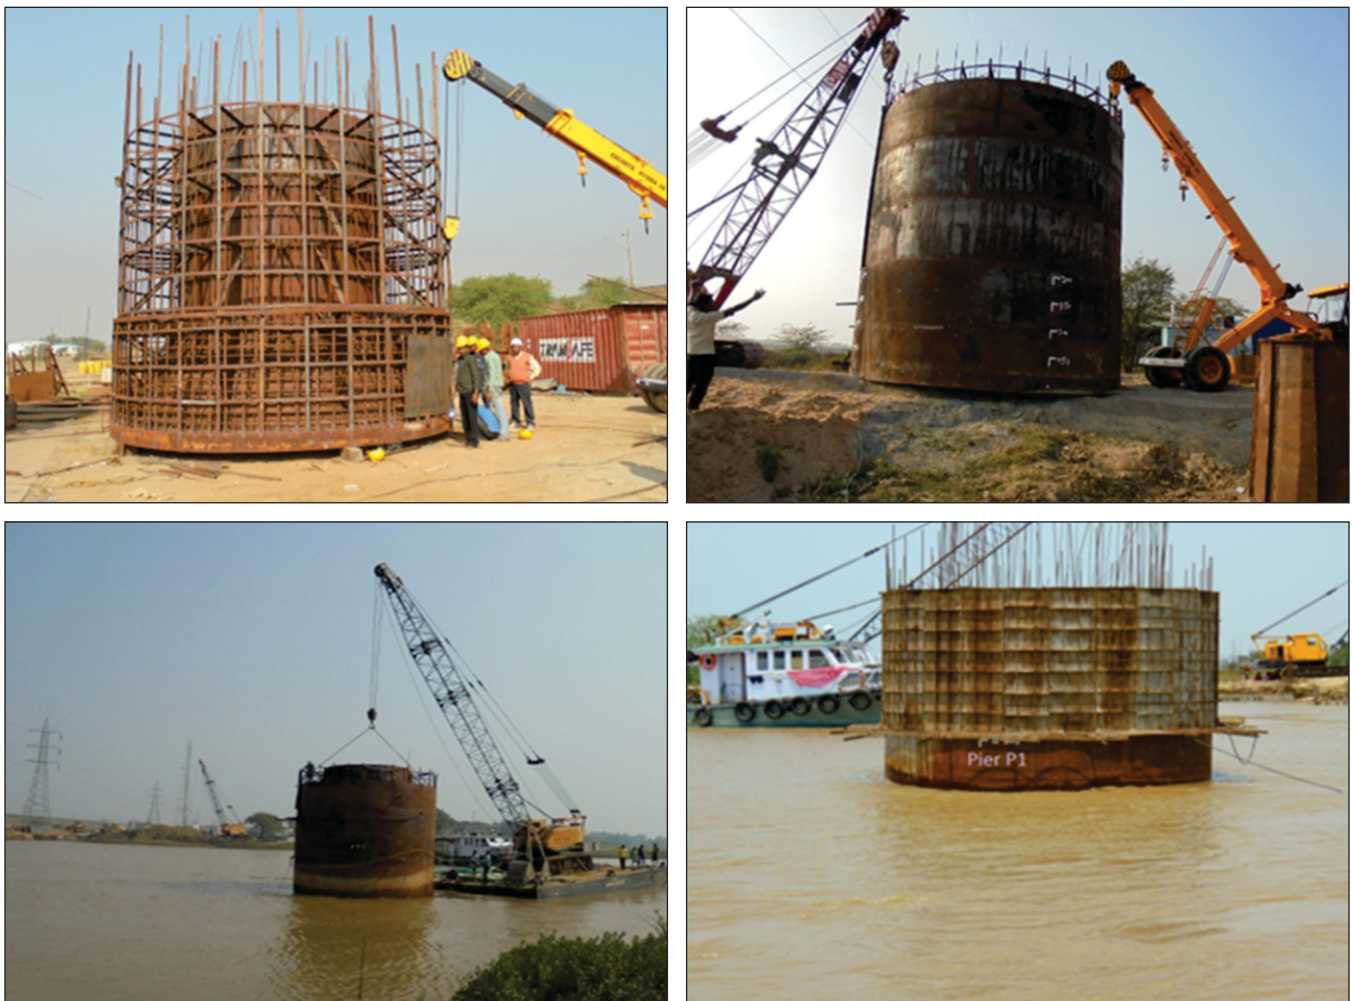
Fig. 2 : Floating Caisson and Casting of Steining

Due to large depth of water (of about 11m), floating caisson had to be resorted to for construction of well foundation. A floating caisson is basically steel shuttering of well having its height (above bed level) more than water level and comprising outer shuttering and inner shuttering as shown in photographs attached in Fig. 2. It is hollow from inside and is towed to the exact location of foundation by tugboats and made to rest on river bed. Concreting of steining between outer and inner steel shuttering is done after steel caisson has been grounded at proper location. In this case of well P-1, concreting was completed in 12 stages, till full height of steel shuttering of caisson as shown in Fig. 2. At this stage height of concreting was 11.8m and sinking was done for 2.1 m.

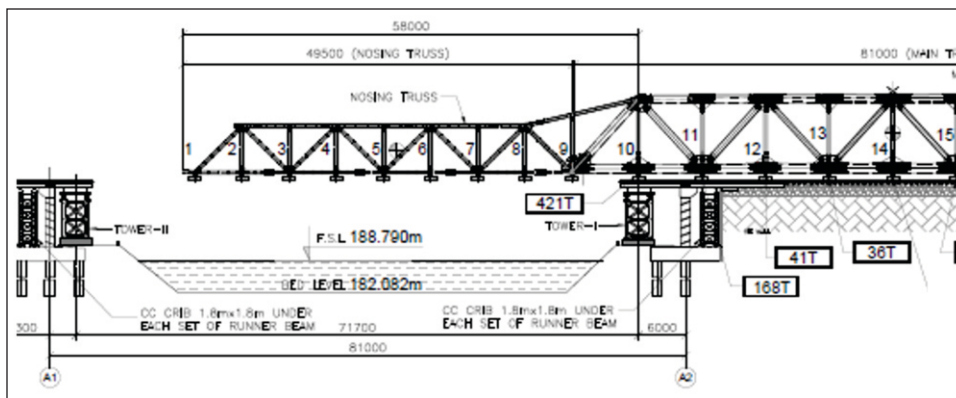
Fig. 1 : Sketch Showing the Launching Arrangement

This Trussed Bridge over canal is spanning 81m from abutment to abutment. The incremental launching of Steel Trusses was adopted in this bridge. This technique was adopted because of restricted access to the site and tight project schedule. Moreover, to cross the canal where any kind of temporary supports are not acceptable by the Irrigation Authority; incremental method of launching is most suited. The design of the "Nose" elements, temporary supports etc. used for launching was one of the critical aspects of the overall scheme. The launching "Nose" adopted here was 45 m in length. Trestle supports were provided in front of Abutments on both sides, temporarily supported on abutment pile cap. RE wall was provided behind the abutment creating gap between them; thus needs running beam to span from abutment cap towards the RE wall side. Rails were attached on running beam for smooth movement As per the scheme the main truss along with the attached "Nose" was pushed gently from one side, unless & until the main truss reaches the other side. For smooth movement trolley wheels were attached under each joint, which was running on rails. Fig. 1 shows the launching arrangement and Fig. 2 shows the photo during launching.
