# Collapse of Precast Arch during construction

## Submergence of High-level Bridge Due to Unprecedented Floods Leading to Unique Rehabilitation Scheme

# Structural Collapse of a Canopy of Platform (COP) during Construction

**Stealing of Fencing wires, Solar Panels, Batteries, Metallic Crash Barriers and parts of Electric Poles from Highways and Expressways – A growing menace**

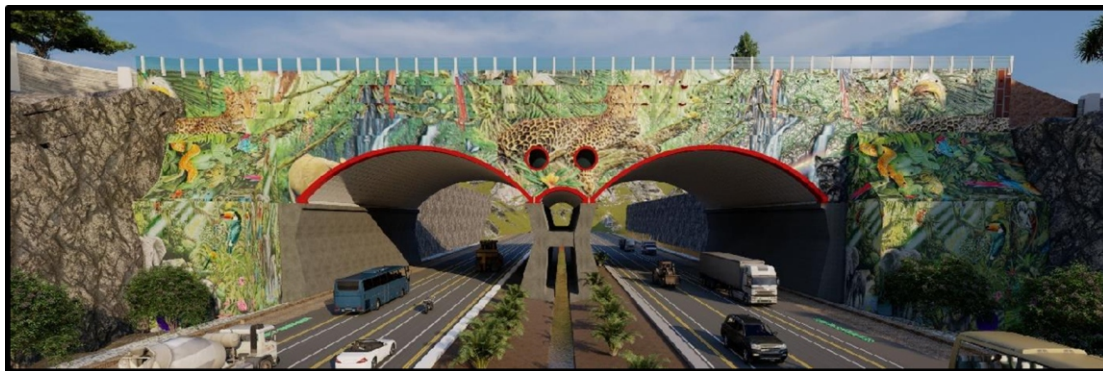
Fig. 1 : Representative image of the structure

The bridge is resting on an open foundation. Abutments of 13.5m in height are proposed. RCC H frame type central pier of 14m height is proposed with combined footing. H frame pier at the middle is designed to give aesthetic shape. The gravity- type retaining wall is proposed over filling of plum concrete behind the abutments. Fig. 1 shows the representative image of the structure and Fig.2 shows the general arrangement of the arch bridge.

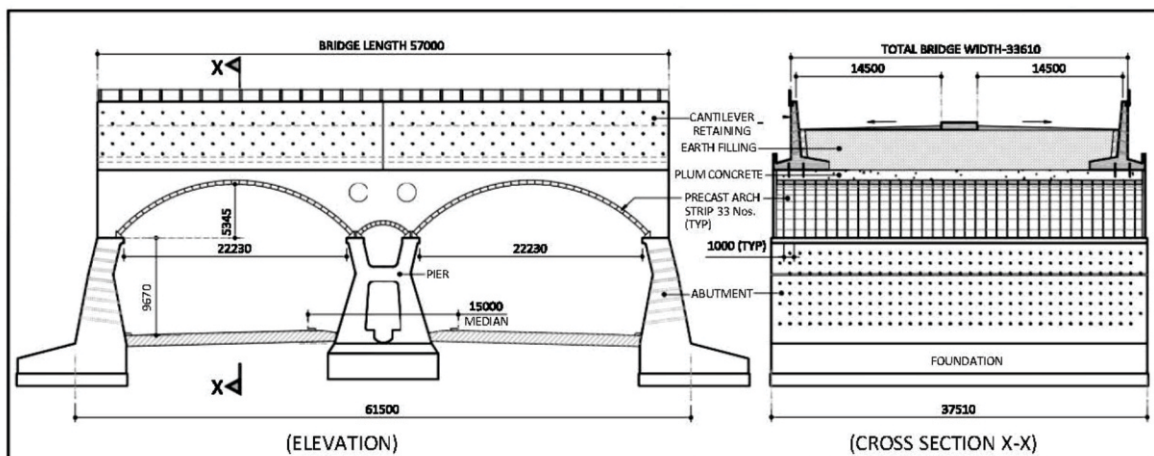
The superstructure of this bridge comprises two major arch spans of about 23m (with a rise of 5m), constructed using precast PCC segmental arch elements of 0.4m arch thickness. The haunch filling above the segmental arches is proposed with plum concrete. The arches comprised of 33 number of blocks of size 0.80m (top width) x 0.78m (bottom width) x 0.40 (thickness). Overall length of the bridge is 57m and the overall width is 36m. The animal overpass is designed over 3 lanes on each side. In total, 70 numbers of major arch strips were proposed in both spans. A central minor arch was proposed above the pier for added aesthetics to the structure. The span of the minor arch was about 4.5m (with a rise of about 1m).

Fig. 2 : General Arrangement of the Bridge

Soil filling of 4.0m height was provided above the superstructure with a retaining wall on both sides to retain soil. The plum concrete in PCC M15 (60% concrete & 40% rubble) was provided as a haunch fill above the arches. With two circular openings of 2.0m diameter above the pier from aesthetic considerations.

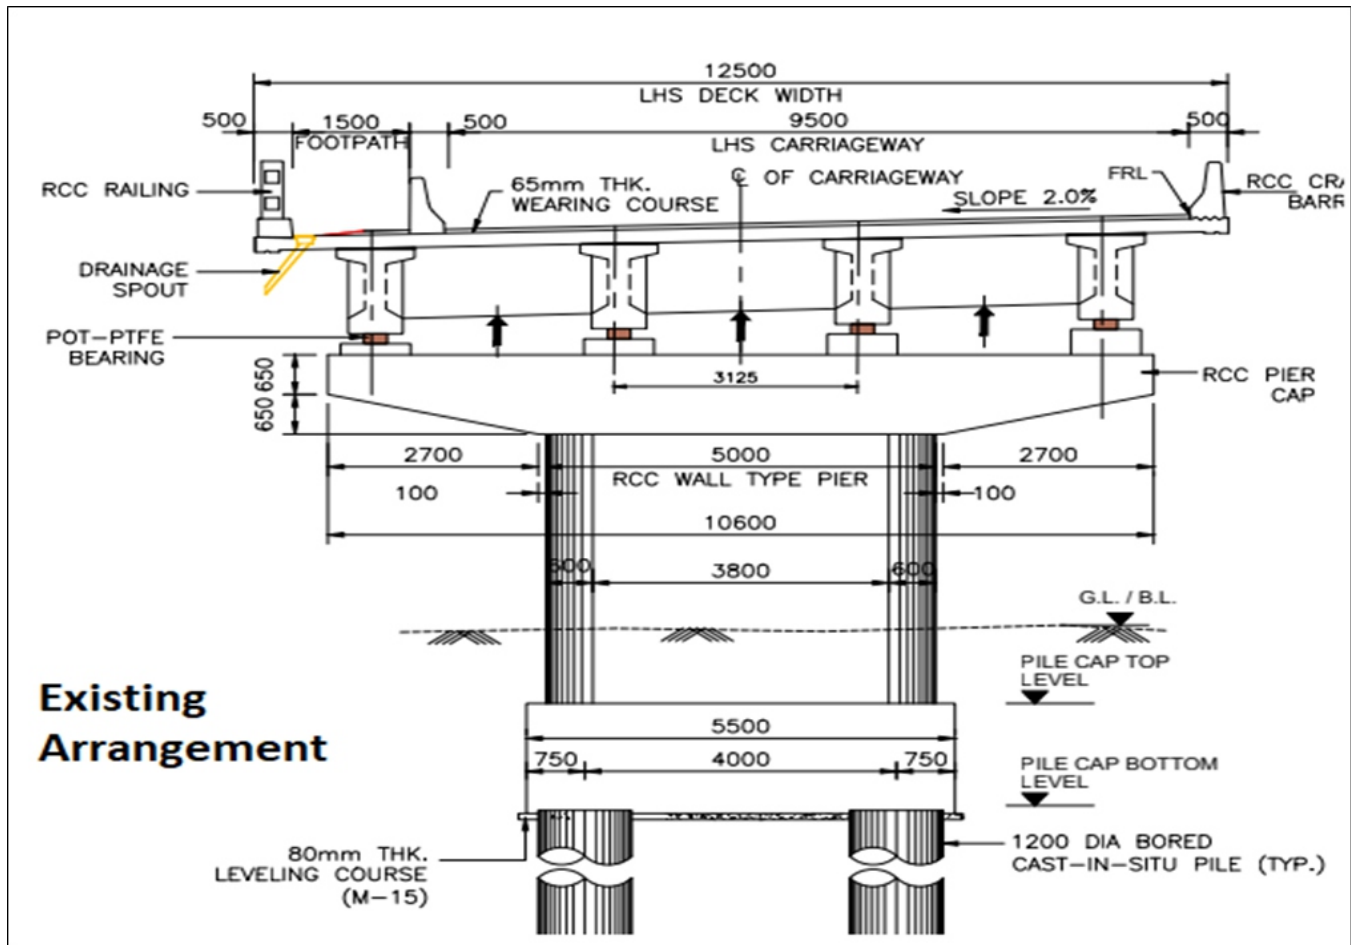
After flood water receded, a joint site inspection by team of designers, Authority's representatives and contractor was conducted to study the condition of this bridge. The bridge was found structurally safe. Though HFL had crossed FRL of this bridge, there was no evidence of scour marks. Thus, scour depth as considered in the original design was found to be safe. Considering the importance of this major bridge to always remain accessible, no matter what, Authority asked structural and highway designers and contractor to re-work the design and construction of this major bridge. It was decided to further raise FRL by 4.61m of this major bridge immediately so that even in unforeseen circumstances bridge will always remain at high level. The deadline for completing the work of raising of FRL of this was bridge was decided to be completed before next monsoon season.

Fig. 2 : Existing Arrangement prior to flooding
